Wienerberger Technical Guidance

LIME LEACHING

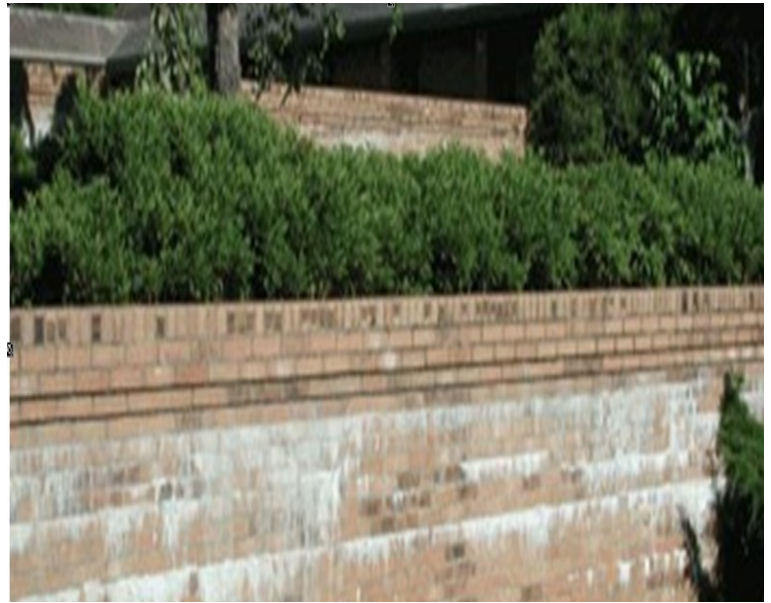
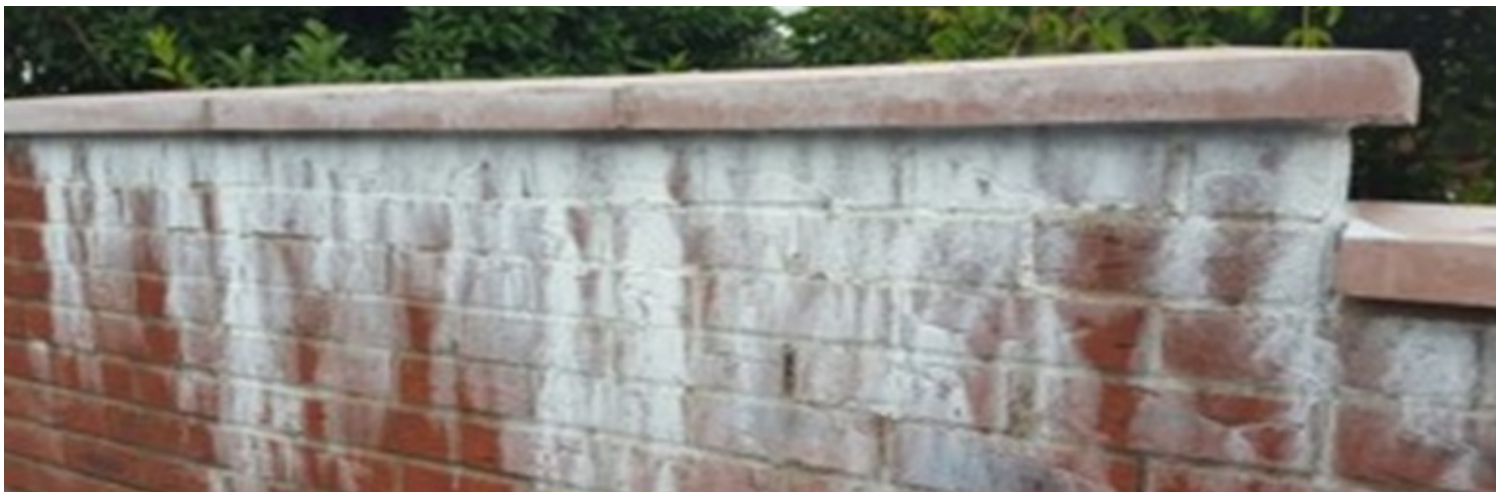
Lime leaching is caused where excess water flows through cementitious material. Water can dissolve calcium hydroxide (free lime) which is then deposited on the brick face. The calcium hydroxide is a soluble form of lime which is created as Portland cement hydrates.

The source of the lime may be the cement from mortar joints, or it may come from concrete or cast stone elements, for example a coping above a brick wall, or a floor slab built into the brickwork.

Lime material washed from mortar joints can be due to lack of adequate protection against rainfall during construction.

The leaching is often seen 'dribbling' from weep holes or fine separation cracks between brick and mortar joints. The calcium hydroxide reacts with carbon dioxide in the air, producing a hard crystalline formation of calcium carbonate.

Although white in appearance, the staining is distinctly different to the soluble salt deposits (efflorescence) which can sometimes appear on brickwork. The initial staining can be removed with water and brushing before it carbonates, but once reaction has taken place an acid solution will be necessary to break down the material.

Proprietary brickwork cleaners tend to be hydrochloric acid based (diluted to the manufacturers recommendations) and appropriate care in handling and protection must therefore be followed. It is important that brickwork is pre-wetted prior to application of any chemical cleaning solution. Only small areas should be treated at any one time. We would also advise that a small, discreet test area should be treated initially. The proprietary cleaning solution manufacturers' recommendations should be followed after the pre-wetting. Although there is a detrimental effect to the aesthetics of the wall, bricks are not affected with regards to durability or structure.
