Wienerberger Technical Guidance

PEACOCKING

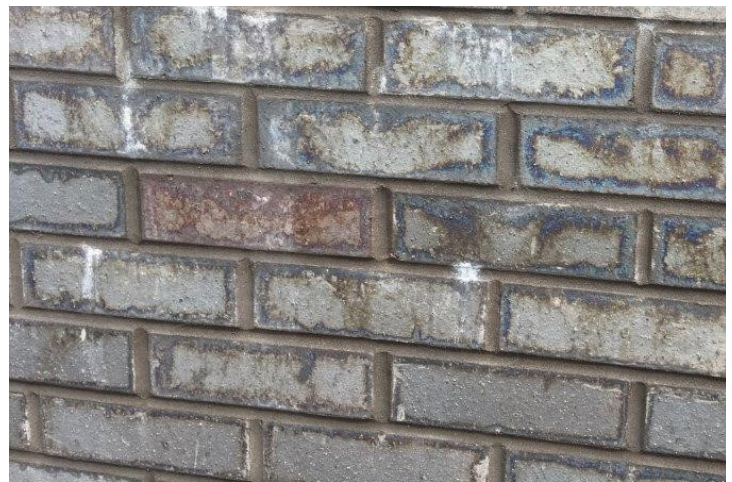
Peacocking, or as it is sometimes known picture framing, can often manifest itself on blue bricks as an oily coloured type of stain.

This is a normal feature of blue clay brickwork due to the shimmery/shiny effect of the colour and is caused by light refraction through a very thin layer of silica in the bricks surface layer.

Peacocking

To minimise the effects of staining on blue bricks, good site practice should be adhered to following the recommendations in PD6697. Stored bricks and newly laid brickwork should be kept as dry and clean as possible and mortar should not be excessively wet. Dependant on the season, freshly laid brickwork is vulnerable to environmental conditions for the first 3-5 days as mortar is still going through the curing process. Waterproof sheeting should therefore be used to protect fresh mortar and open cavities, and stop brickwork from becoming saturated.

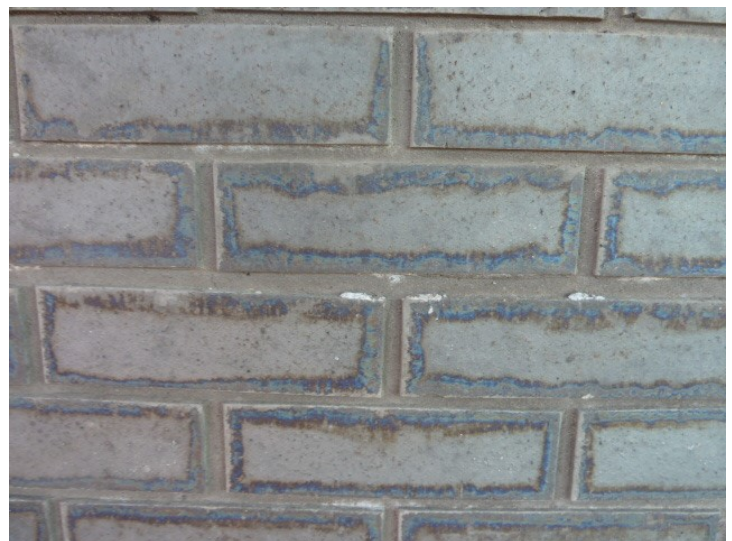
This can be caused by saturation of brickwork prior to the mortar curing, or through the use of excessively wet mortar. This gives a picture frame effect with the dark staining around the edges of the brick. Saturation of bricks or mortar may also result in free lime in the mortar being released and thus lime leaching from the joints may also occur (see Lime Leaching Technical Guidance Sheet for more information). Staining from wet mortar being washed across the face of the brick by rain will also be more noticeable on blue bricks.

Picture framing
