Wienerberger Technical Guidance

EFFLORESCENCE

EFFLORESCENCE IN BRICKWORK

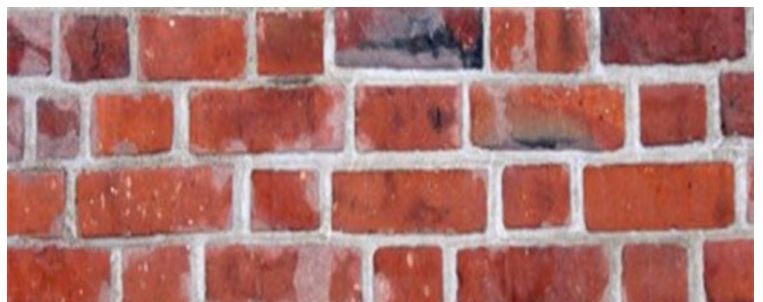
Although it is usually a harmless problem, there have been cases of damage caused by efflorescence. Crystallisation of salts just below the surface of the brick can cause spalling – this is known as cryptoefflorescence. This problem is often associated with magnesium salts. Cryptoefflorescence is associated with a large build-up of salts and usually occurs where old, relatively weak bricks are re-used inappropriately, particularly in areas of excessive dampness. It can also occur if the brickwork has been covered by a surface treatment because the salts may crystallise behind.
